**BUILDING A BEACON: FEASIBILITY STUDY FOR SPACE SHARING** 2364 E. Cumberland St. Philadelphia, PA 19125

**EXISTING SITE PLAN**

Project number:  
2017-03  
Date:  
24 MAY 2017  
Scale:  
AS NOTED

### EXISTING FIRST FLOOR PLAN

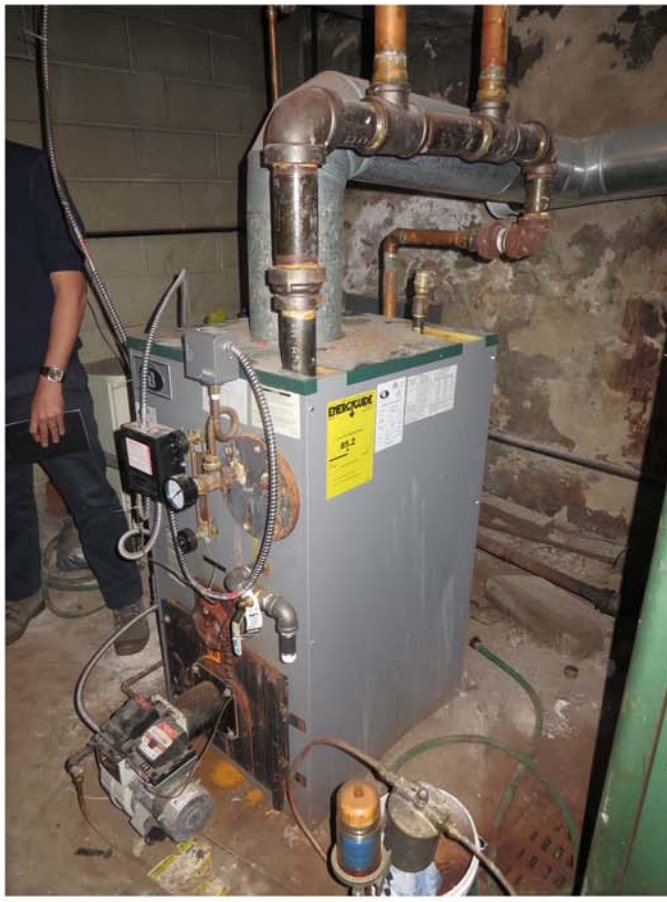
1

This recently installed 212 MBH oil fired steam boiler supplies steam to the cast iron radiators located throughout the building. Condensate is returned to the new boiler through condensate pipes, but not much is received by the boiler. Adjacent to this is the old boiler abandoned in place. There is no cooling that currently services the building.

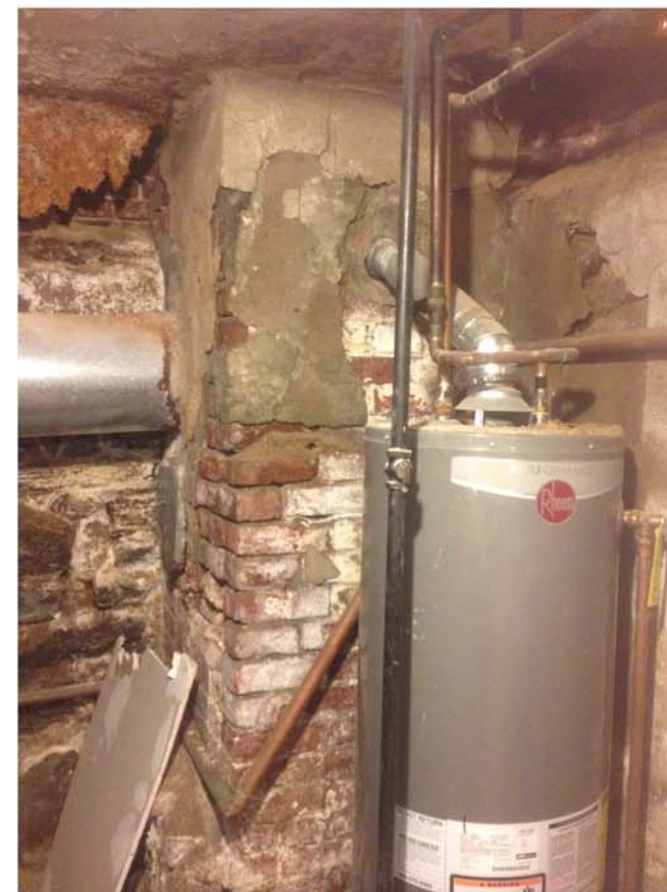
2

Domestic hot water is provided by a 40 gallon natural gas fired water heater located next to the abandoned boiler and run through the mechanical chase. It lacks a recirculation line. Cold water is supplied to the building plan NE through a 3/4" line. Sanitary leaves the building through a 4" line plan NW.

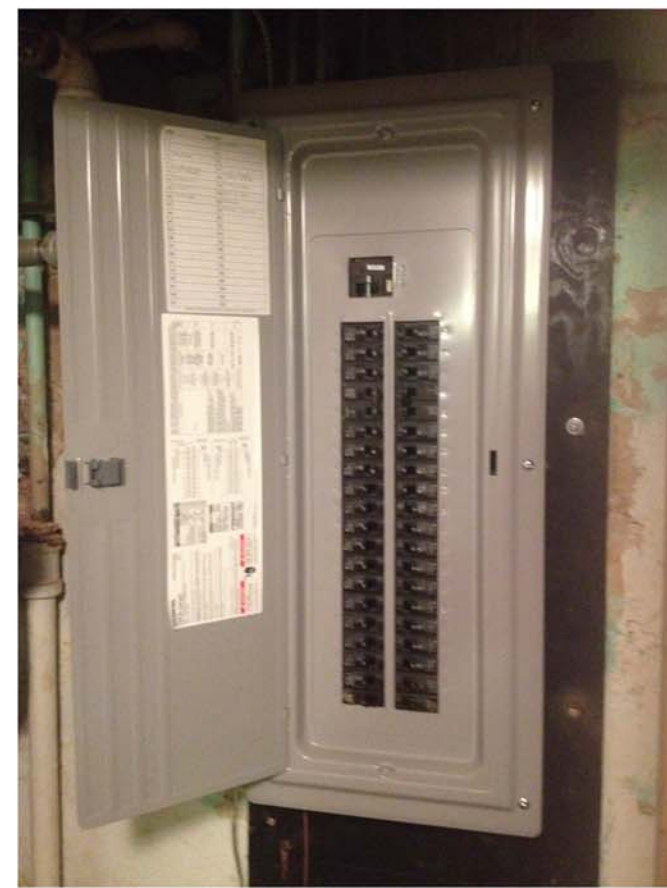
3

The building is serviced by a 200A 240V service. The main circuit board is located in the electrical closet located in the kitchen area. The distribution panel was recently installed and appears to be in good working order with ample capacity. The distribution wiring is from a previous renovation, although it is in servicable condition.

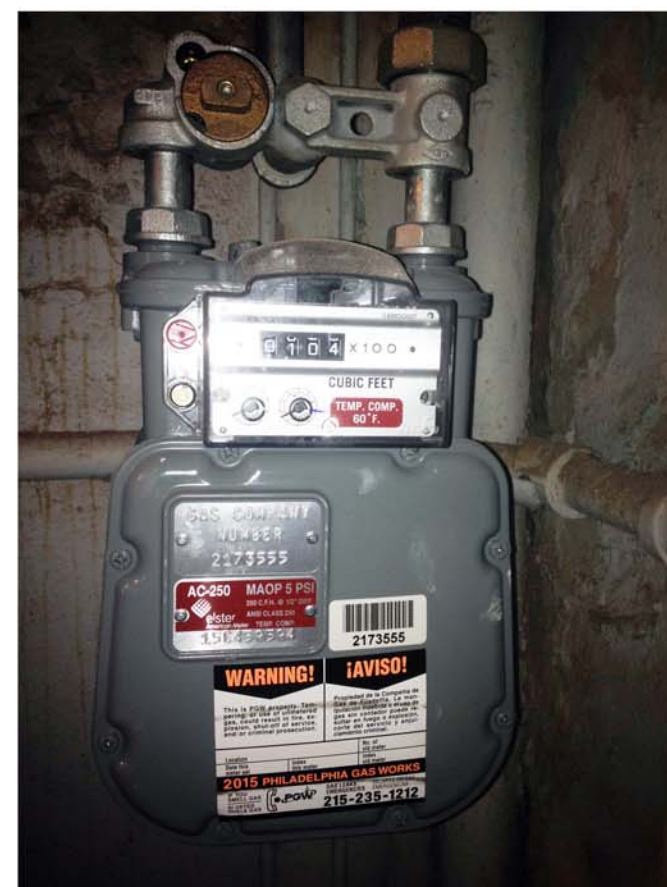
4

Much like the water and electric supply, natural gas is fed into the building through the mechanical closet in the NE corner of the kitchen. It is being supplied through a 1" line to the water heater, the boiler, and gas fired stove.

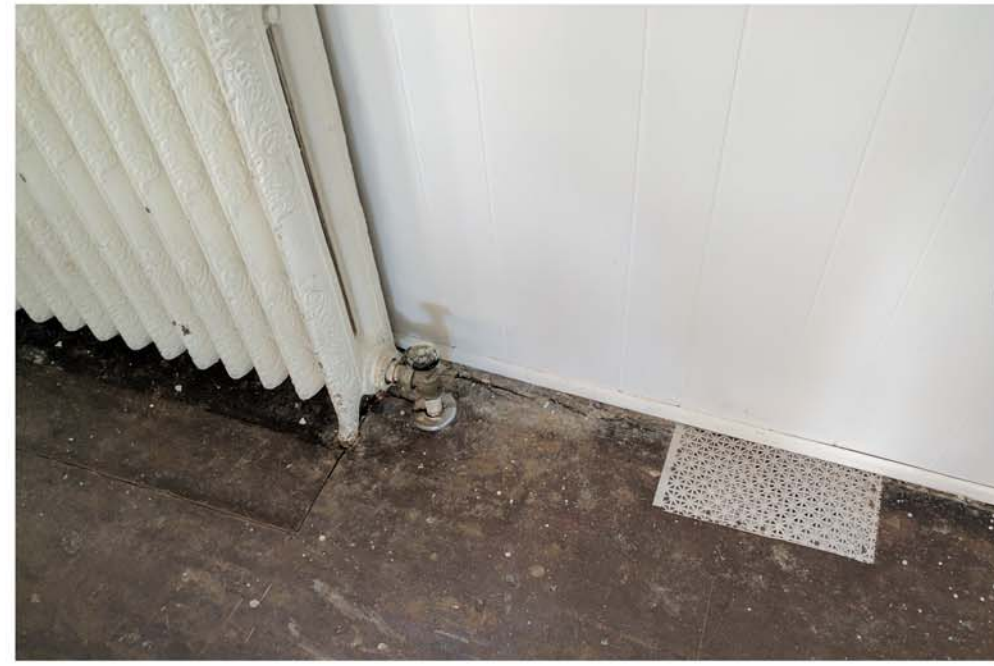
6

Extensive water damage has occurred at this area underneath the existing window. Presumably the water is penetrating the masonry wall and effecting the finished wood flooring. This picture also an example of the cast-iron radiators that occur throughout the building to heat the space. These include a condensate pipe that returns to the boiler in the basement, though it appears little of the condensate is received by the boiler.

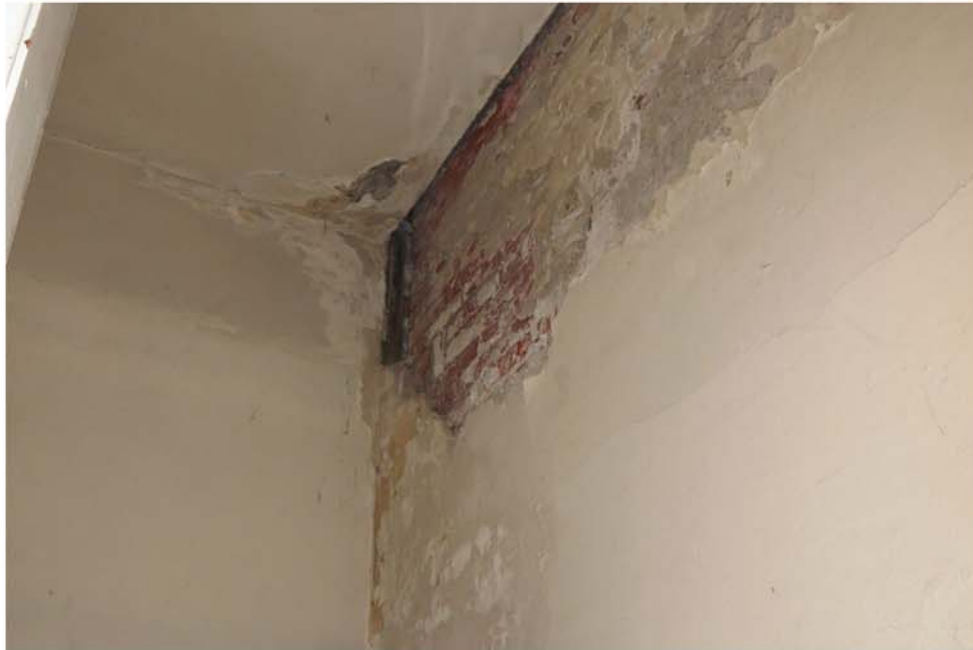
7

Extensive water damage has also occurred at this corner of the ceiling in the stair enclosure. Moisture, presumably, is penetrating through the cementitious masonry and ruining the dywall finish on its interior. A similar condition exists at floor level at this location. Remediation should be done earlier on to prevent further damage and growth of mold.

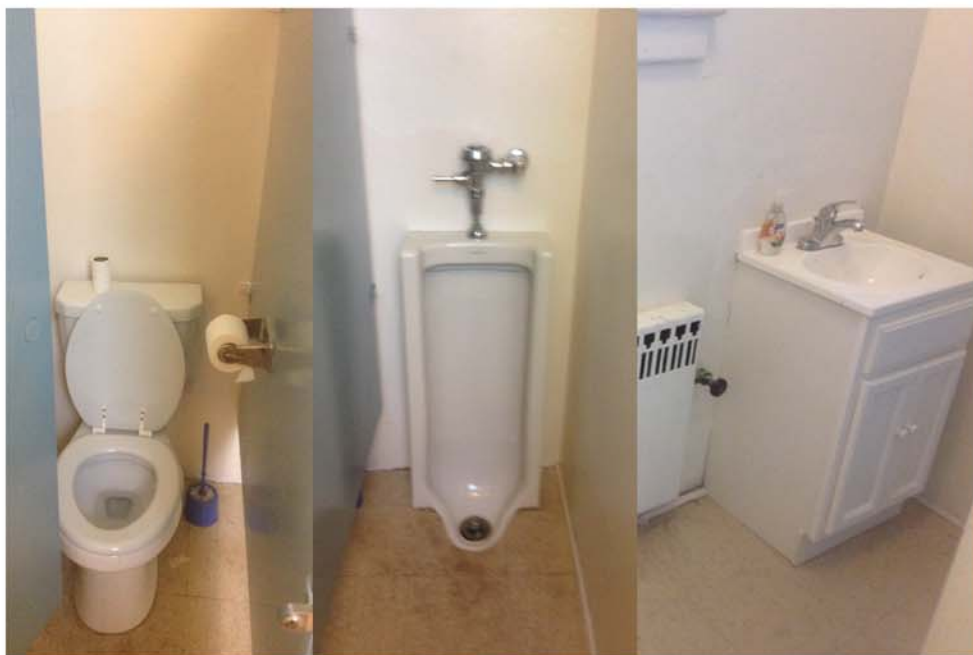
8

The restrooms are in working order and are without water damage. The fixtures seems to flush well and are in good shape. The restrooms themselves are out of compliance with accessibility guidelines and would need to be redone depending on the scope of renovation or reconstruction, but have adequate plumbing and hot water.

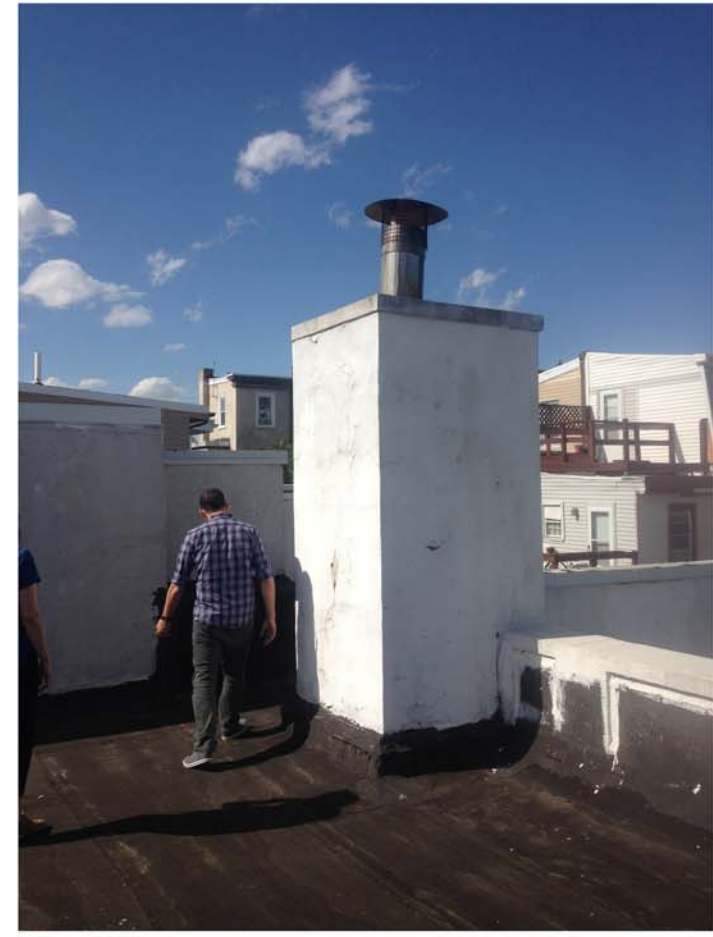
9

Pictured here is the chase that houses the water lines that service the bathroom below, and vents the boiler through the roof.
